# NEWBURG MILL DAM

## NJ 00779

PHASE 1 INSPECTION REPORT  
NATIONAL DAM SAFETY PROGRAM

AUGUST 1981

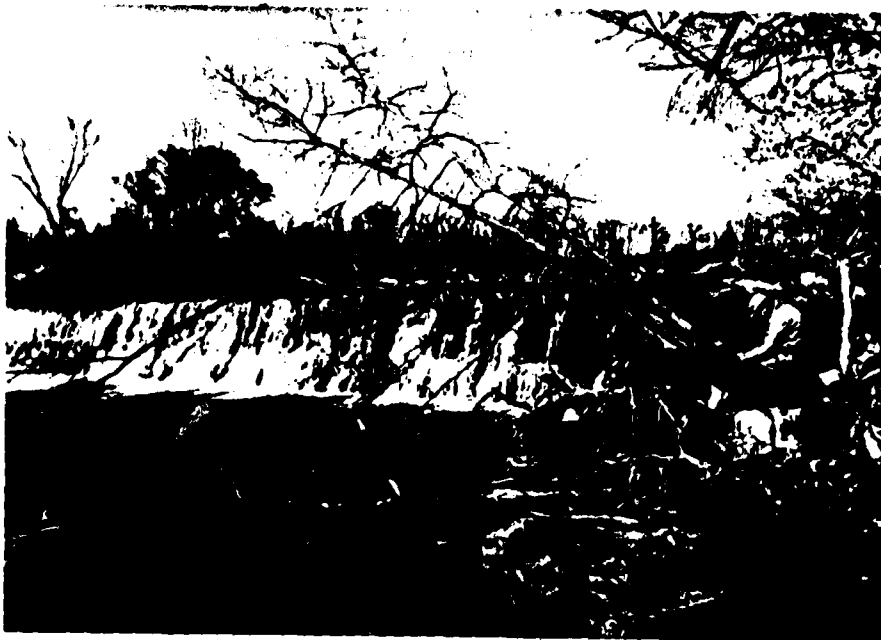
6.1 Evaluation of Structural Stability. The erosion at the left abutment and the collapse and deterioration of the left spillway training wall (emergency spillway) on the left side of the dam, if allowed to continue, could result in the eventual breaching of the dam. Seepage and deterioration of the concrete to the right of the gated spillway and along the foundation of the former raceway structure could contribute to future stability problems for these structures, if allowed to continue.

View looking at downstream face of dam from left bank. Note deteriorated condition at left (east) spillway abutment.

(1) Oversee repair of the erosion on the left abutment.

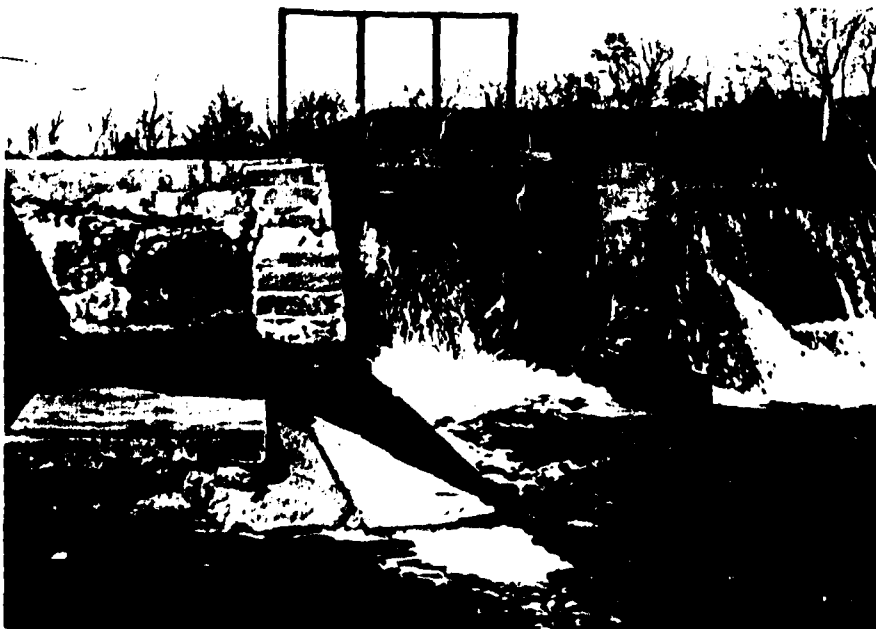
View of a stoplog structure

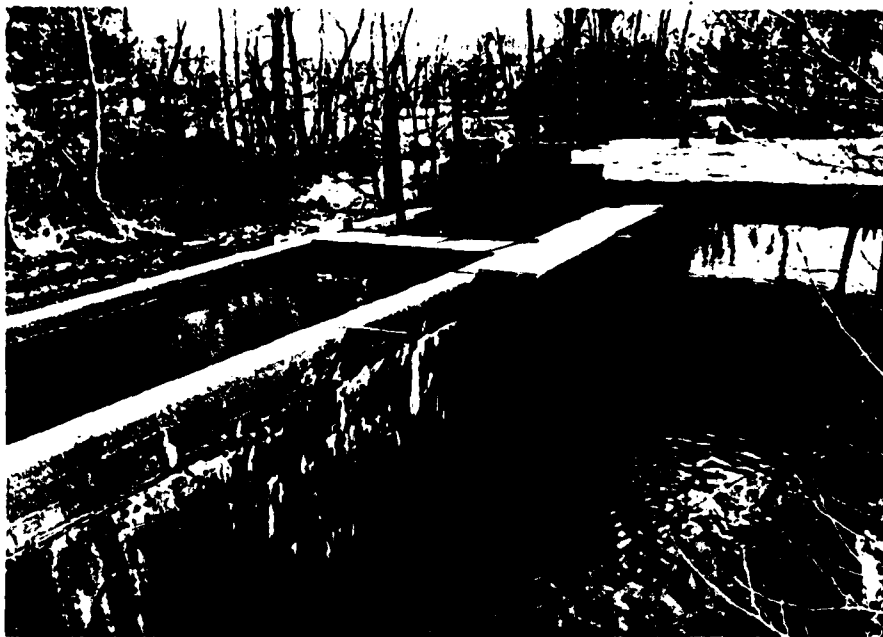
- (4) Headrace. A 10.7-foot wide headrace with a set of 3 gates is contained between concrete walls 1.25 feet wide. Only the head frames of the gates were visible. They are badly rusted. If gates are present they are in a closed position at about 2/3 of the length of the headrace downstream of the dam. The concrete walls are surface spalled with some cracks and minor leakage.
- (5) Filler Walls. Two short concrete walls connect the gate house to the right headrace wall (4 feet) and the gated structure to the left headrace wall (10 feet) respectively. Both walls have spalled concrete on their sloping faces and are leaking as noted above.

Gate headframes in headrace. Note deterioration of walls.  
Mill foundation in background.
